## DYNAMIC BEHAVIOUR OF A STRENGTHENED POINTED ARCH TESTED ON SHAKING TABLE

*This paper presents an experimental study of a strengthened pointed arch subjected to horizontal sinusoidal excitation on a shaking table. The geometry of the arch was selected to represent the geometry of typical Gothic vaults found in small single-nave village churches in Istria with preserved medieval wall paintings. The arch model was constructed from identical timber blocks with dry joints, while the reinforcement (duct tape) was applied either at extrados or at intrados of the arch. The aim of this study was to document the dynamic behaviour of pointed arches strengthened with composites, since there is a lack of experimental tests on this type of geometry. Contactless optical measuring system was used to monitor the openings between the blocks, since conventional sensors are difficult to apply. Two high-speed cameras made it possible to record the formation and closure of hinges between the blocks. Due to strengthening some hinges were hindered and consequently the seismic capacity of the arch was significantly improved.*

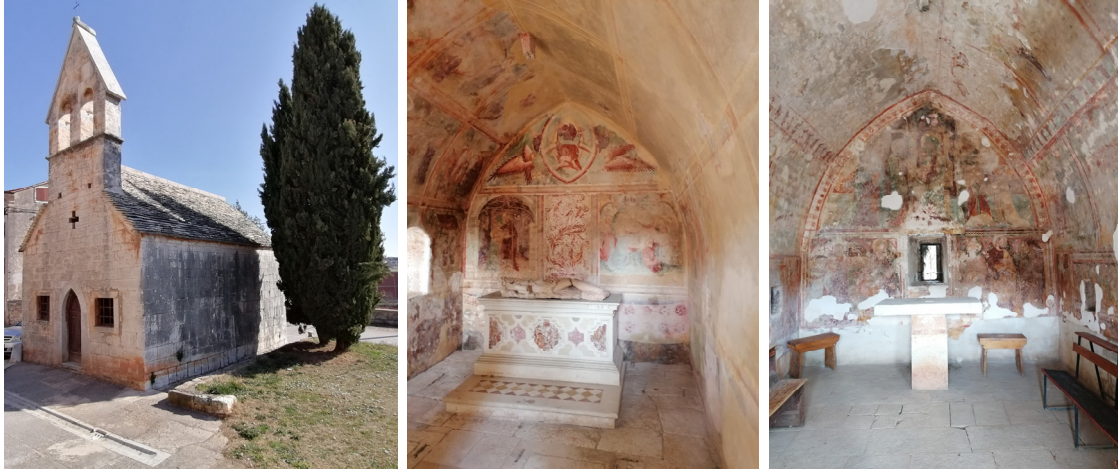
Figure 1: Single-nave churches with pointed vaults in Istria.

The geometry of the arch was selected to represent the geometry of pointed barrel vaults found in more than 15 small single-nave Gothic churches in Istria with preserved medieval wall paintings, which are protected as cultural heritage (Figure 1). Churches with wall paintings are an essential part of the Istrian cultural identity; so far, more than 140 sites with fresco paintings dating from the 8<sup>th</sup> to the 17<sup>th</sup> century have been investigated and documented [13].

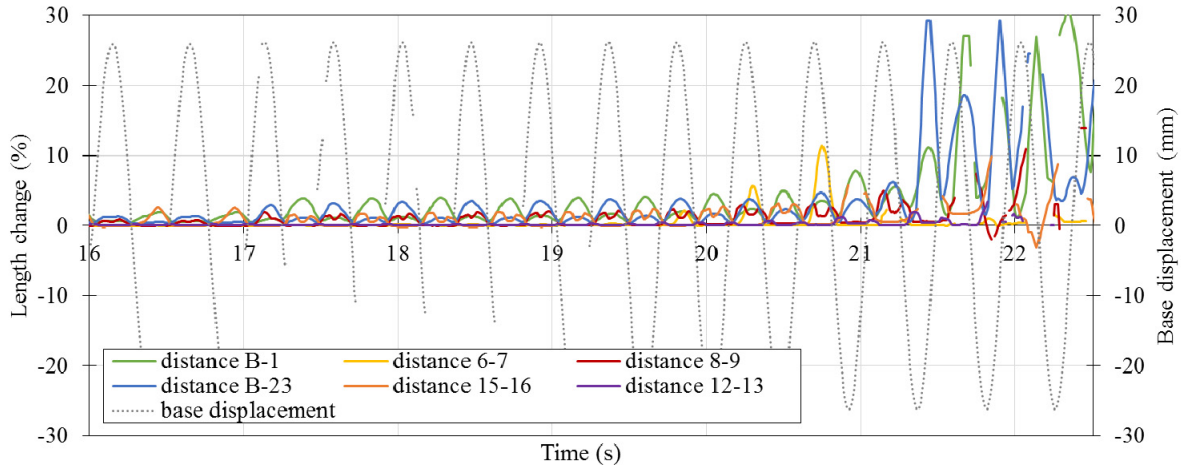
Figure 9: Tracking of openings between blocks via DIC (arch strengthened at extrados).

The opening of some hinges is presented in Figure 9, where data series numbers denote the block numbers (for block numeration see Figure 3), while “B” is the base (for example “distance 6-7” denotes the distance between the round point markers located on blocks 6 and 7). Opening and closing of hinges follow the sinusoidal movement of the shaking table.

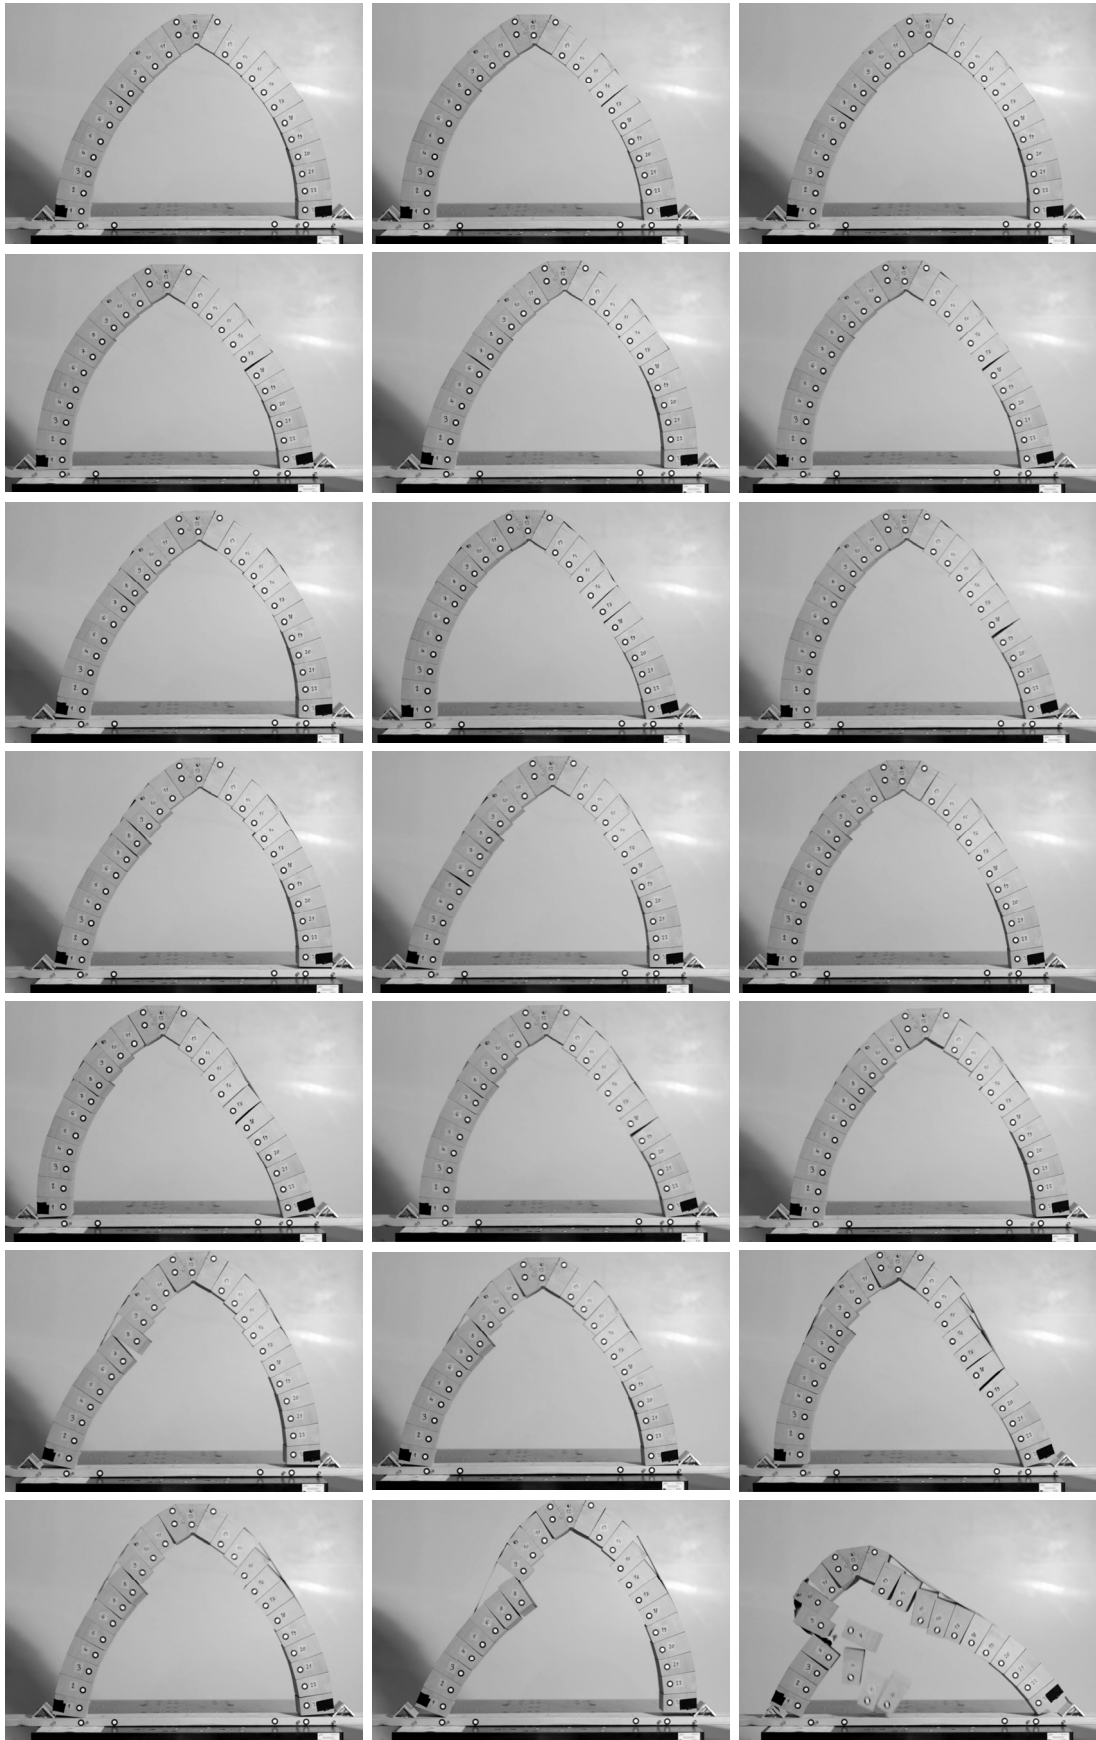
Figure 10: Series of photos documenting testing of pointed arch strengthened at extrados.

Figure 10 reports the shaking table testing of arch strengthened at extrados. The failure mechanism differs from the model without reinforcement - the reinforcement applied at extrados prevented opening of hinges at intrados and caused rocking. Finally, the failure occurred due to loss of anchorage at supports, debonding of the tape and shear sliding. The tensile strength of the reinforcement was actually improperly too high selected so that no rupture occurred.

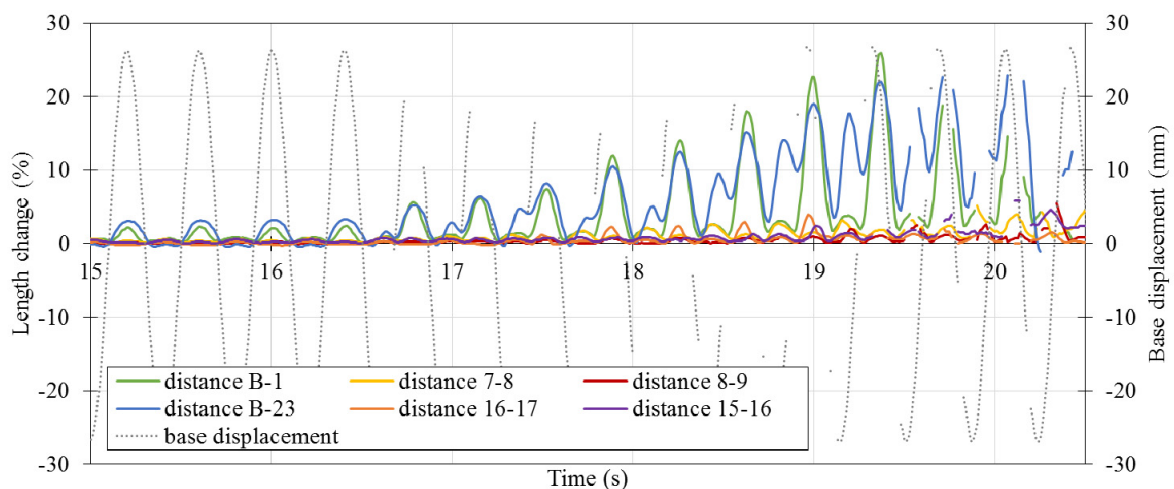
Figure 12: Tracking of openings between blocks via DIC (arch strengthened at intrados).

Tracking of some hinges is presented in Figure 12, while Figure 13 documents the failure of the arch.
